FINAL REPORT OF SPECIFIC PURPOSE LIDAR SURVEY

LiDAR, Breaklines and Contours for Bay County, Florida

State of Florida
Division of Emergency Management
Contract 07-HS-34-14-00-22-469
Task Order 20070525-492718a
PDS Task Order B

October 30, 2009

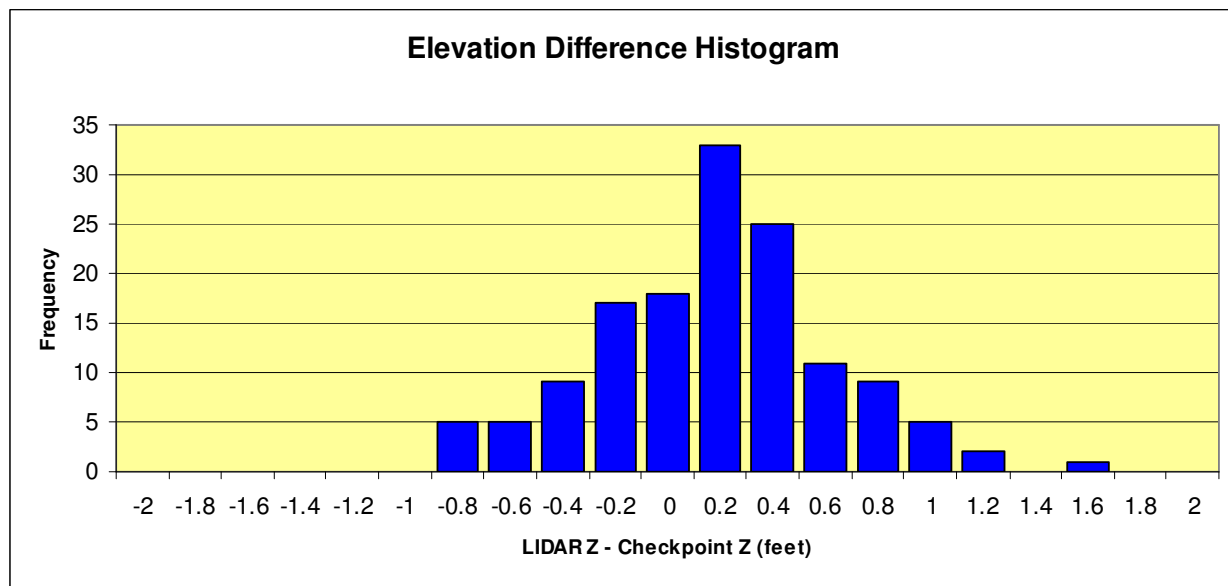
Figure 5 — Histogram of Elevation Discrepancies within 0.02 ft Bands

Figure 5 illustrates a histogram of the associated elevation discrepancies between the QA/QC checkpoints and elevations interpolated from the LiDAR triangulated irregular network (TIN). The frequency shows the number of discrepancies within each band of elevation differences. Although the discrepancies vary between a low of -0.86 ft and a high of +1.50 ft, the histogram shows that slightly more of the discrepancies are skewed on the positive side of what would be a “bell curve,” with mean of zero, if the data were truly normally distributed. Typically the discrepancies tend to skew a bit more to the positive side, because discrepancies in vegetation are typically positive.

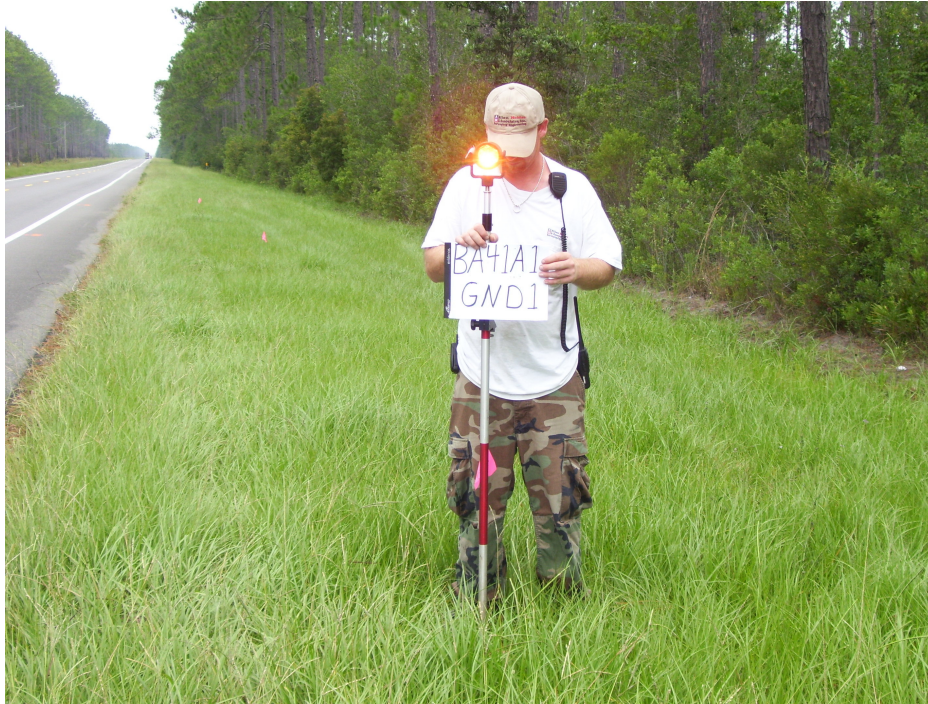
Figure 6 — Field Picture for Checkpoint BA041M1

Figure 6 shows the digital pictures captured in the field for Category 1 checkpoint BA041M1. This point location actually fit the criteria for Category 2 checkpoints, brush and low trees, as the height of the grass exceeds 6 inches – the norm for Category 1. This point was reclassified to Category 2 for the final vertical accuracy calculations.

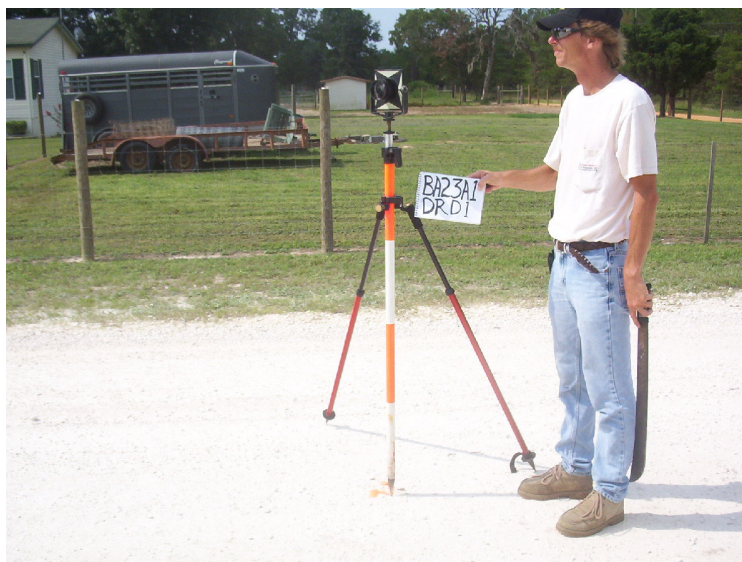
Figure 7 — Field Picture for Checkpoint BA023M1

Figure 7 shows the field picture for Category 1 checkpoint BA023M1. It is clear from this picture that the sand/gravel road is level in this area.

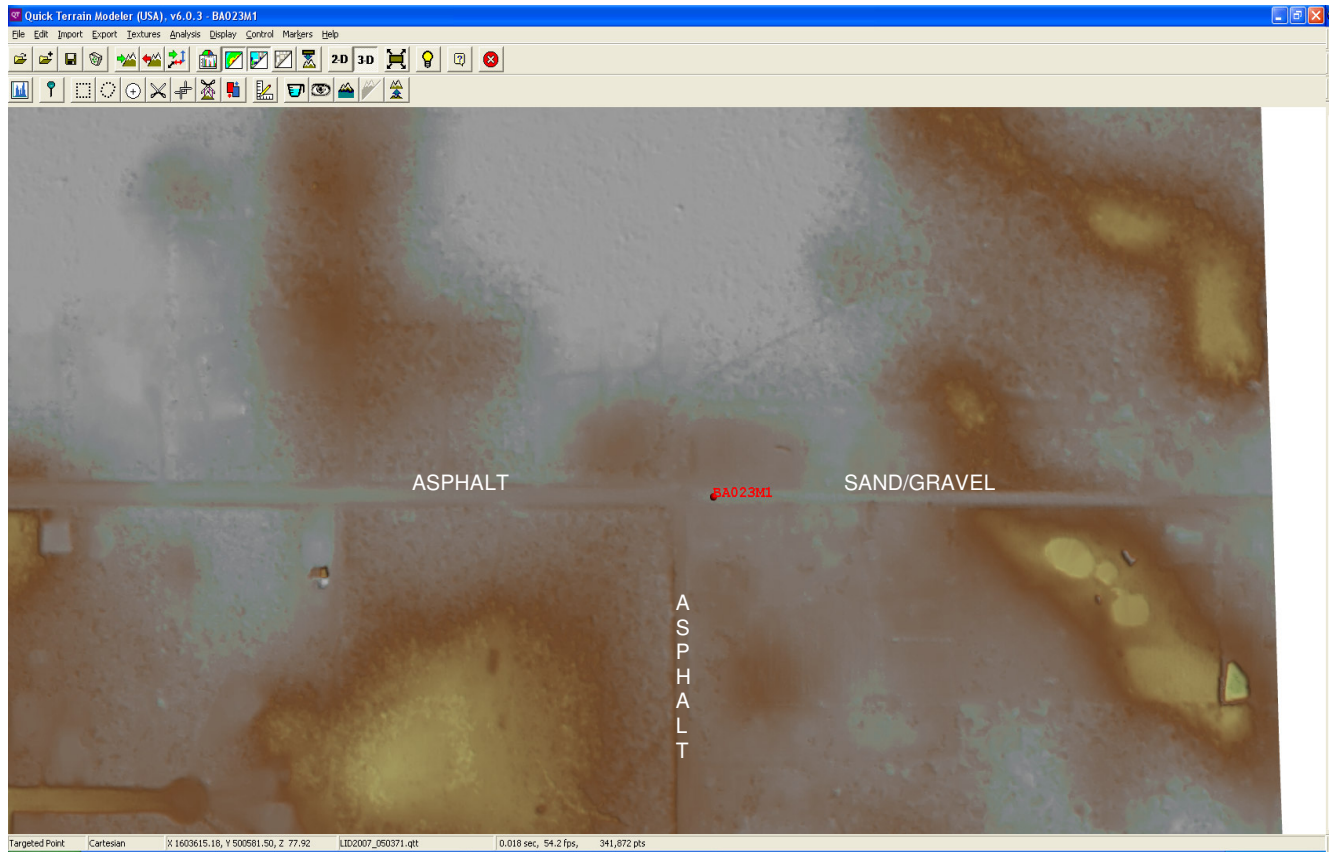
Figure 8 shows a colorized TIN of the bare-earth surface and the location of checkpoint BA023M1. The sand/gravel comes in from the east and meets up with the asphalt road intersection.

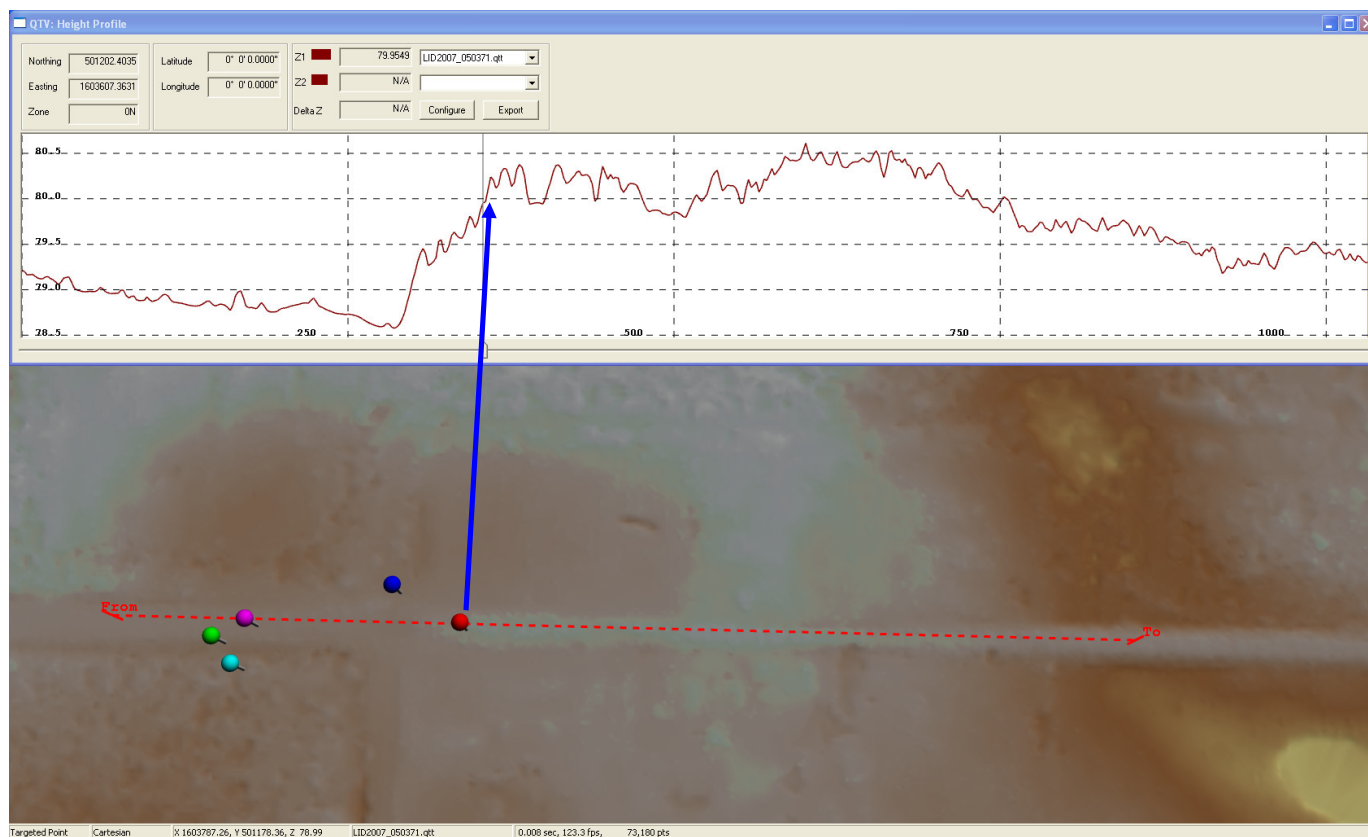
Figure 9 – Split-screen profile showing the location of BA023M1 on the profile line

Figure 9 shows a screen shot of a splits-screen profile taken along the centerline of a portion of the asphalt road. The blue arrow shows the location of BA023M1 on the profile line. This point is 0.821' higher than the checkpoint elevation of 79.27'. The Lidar was acquired on 7/9/07 and the survey was 8/6/07, evidence that new sand/gravel may been put on this portion of the road just prior to the Lidar acquisition and subsequently graded level prior to the checkpoint survey. This point was not used in the vertical accuracy assessment.

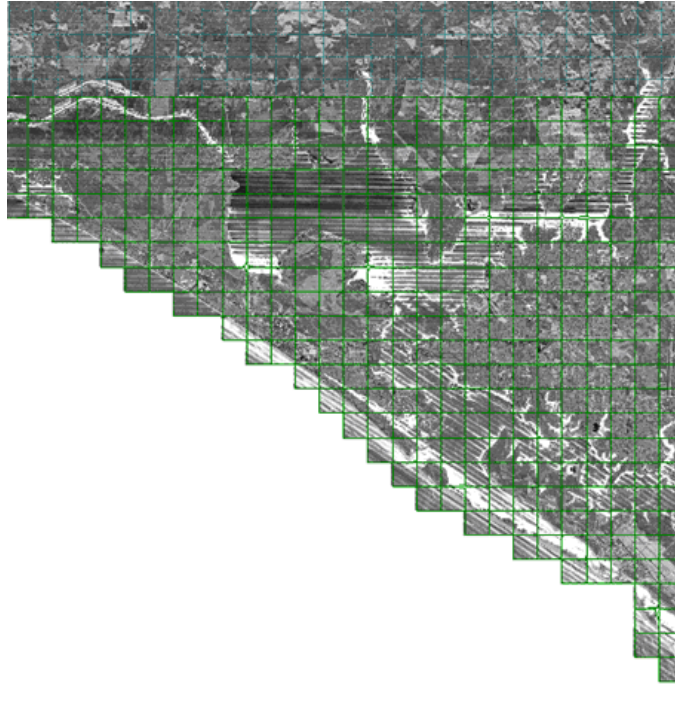
3. *Data Void/ Gap Checks*-The imported .LAS files were used to create LiDAR “orthos”. The LiDAR orthos were one of the tools used to verify data coverage and point density, to check for data voids or gaps, and to use as reference data during checks for data anomalies and artifacts. This product is not intended to be a project deliverable. The orthos were derived from the Full Point Cloud elevations and LiDAR pulse return intensity values. The intensity values were used as delivered with no normalization applied. Due to the point density of the Florida Baseline Specifications, the orthos were produced at 1 foot pixel resolution for the entire area of interest (see Figure 1).

Figure 9 Screenshot of Coastal Bay County LiDAR Orthos produced from Intensity Returns

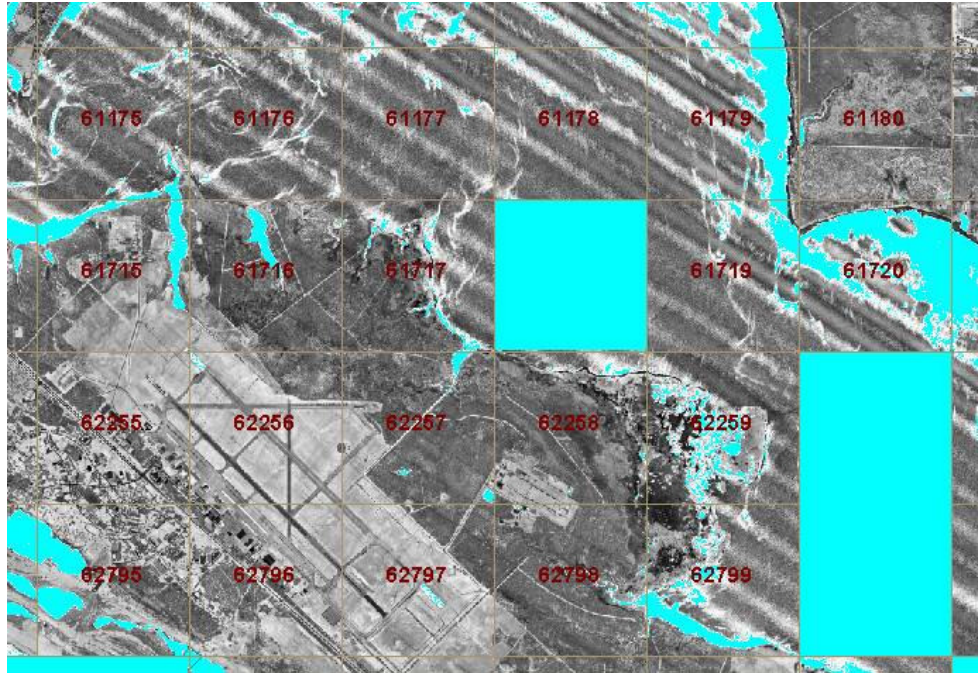
Coastal Bay County contained data voids (areas with no LiDAR returns in the LAS files). These voids are present in the majority of LiDAR projects due to large bodies of water. These are considered to be acceptable voids (Figure 2).

Figure 10 Acceptable voids in data due to water bodies

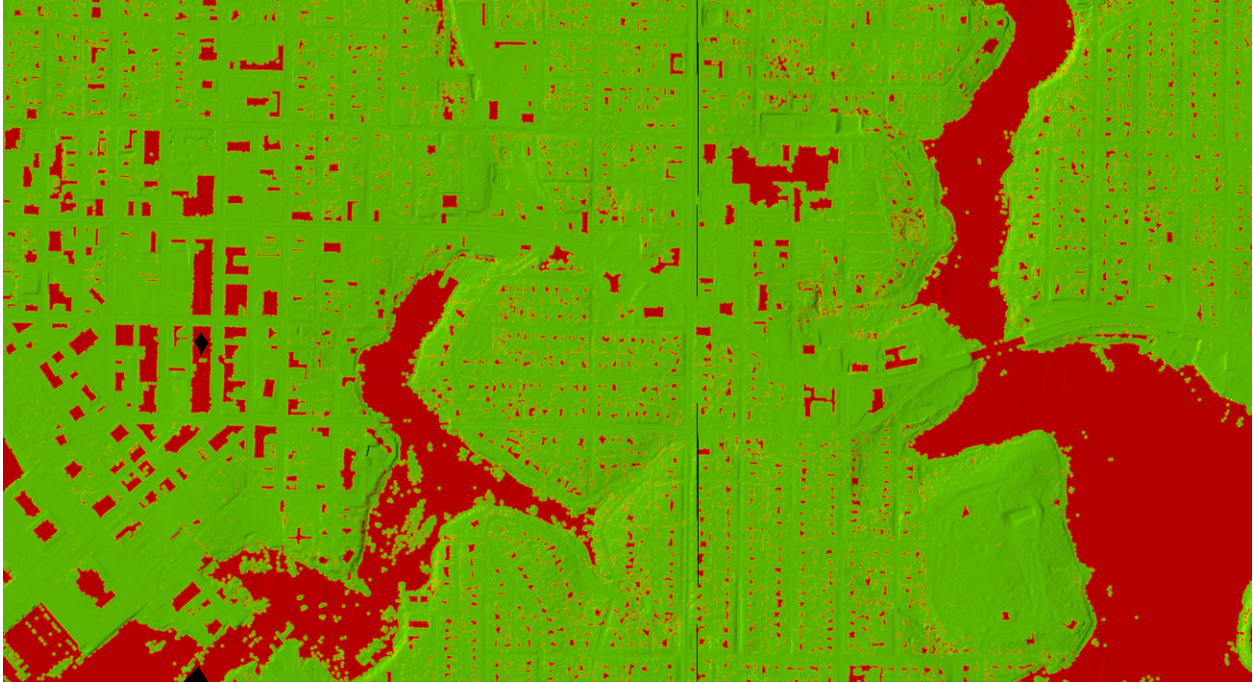
Model statistics were produced and characterized by density, scale, intensity, and elevation. (Figure 5) The low confidence area polygons were overlaid onto the density grids to ensure that all low confidence areas were properly identified with a polygon. As with the LiDAR orthos, this product was produced for Quality Assessment purposes only.

Figure 11 LID059011 and LID059012: Density grid of Bay County, created using a green to red color ramp. Green areas meet project specifications; red delineates areas not meeting minimum density requirements (primarily water, buildings and low-confidence areas)

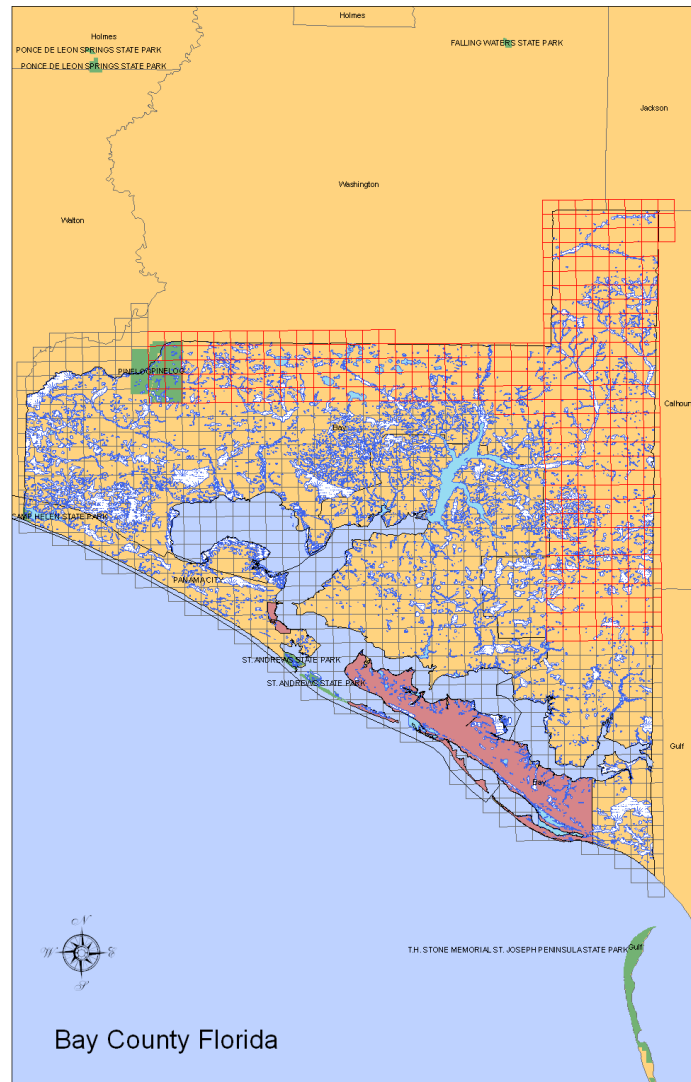
The project area in Bay County, Florida is predominantly coastal with large internal water bodies. There is a large urban area, Panama City, and also Tyndall Air Force Base (highlighted in red in the figure below). There is one State Forest, Pinelog. There are several Small State Parks. It has significant marsh areas. (Figure 4).

Figure 4 Map of Bay County Florida with Marsh areas from Florida Geographic Data Library (FGDL) areas designated with red tiles were acquired by the Sanborn Map Company in a previous flight acquisition then the FDEM Bay County Lidar acquisition project.

The initial data acquisition was very dense. Overall the calculated average maximum point density of all the Bay County LAS files was .48m. In general, the bare earth ground surface was clear of artifacts and very clean. The algorithms used to classify the above-ground ground points were very stringent; given the overall physical characteristics of the county this does not seem

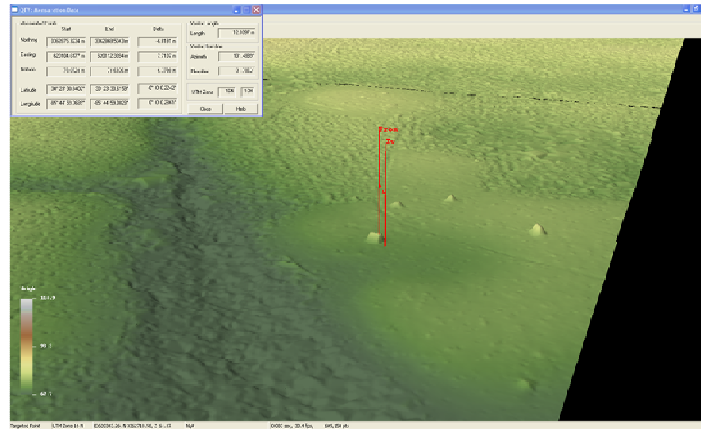
Figure 12 Tile 049299 – artifacts in ground points.

Tile	Issue	Code
49299	Spikes - Artifacts	Corrected
49300	Spikes - Artifacts	Corrected
49818	High Points in Low Confidence Areas	Corrected/Reclassified
46066	High Points in Low Confidence Areas	Corrected/Reclassified
46068	Flightline-step	Noted: Existing Data
46069	Flightline-step	Noted: Existing Data
54152	Lack of points on open road surface	Noted
47655	Docks & Piers left as ground points	Corrected
46604	Irregular Terrain surrounding open field	Noted

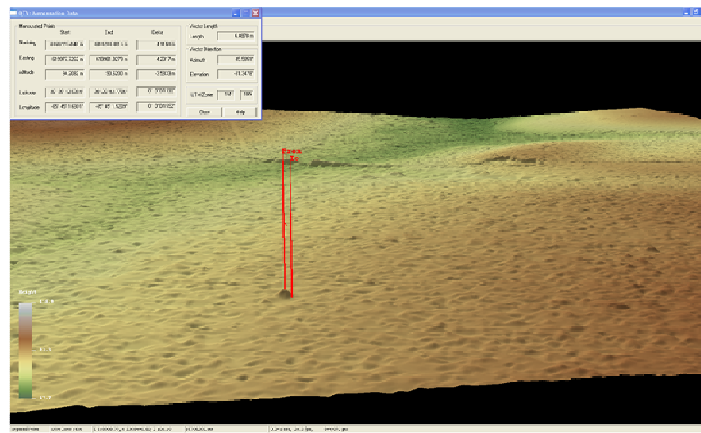
Figure 13 Tile 049300 _artifacts in ground points.

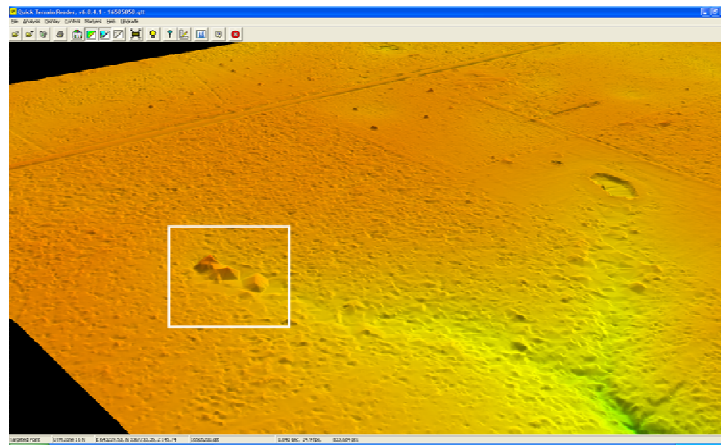
Figure 7 Tile 049818 – High points in low confidence area.

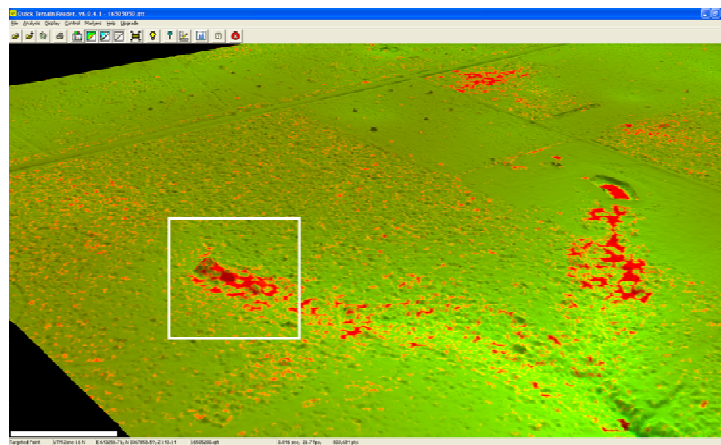
Figure 8 Tile 046066 – High Points in Low Confidence area

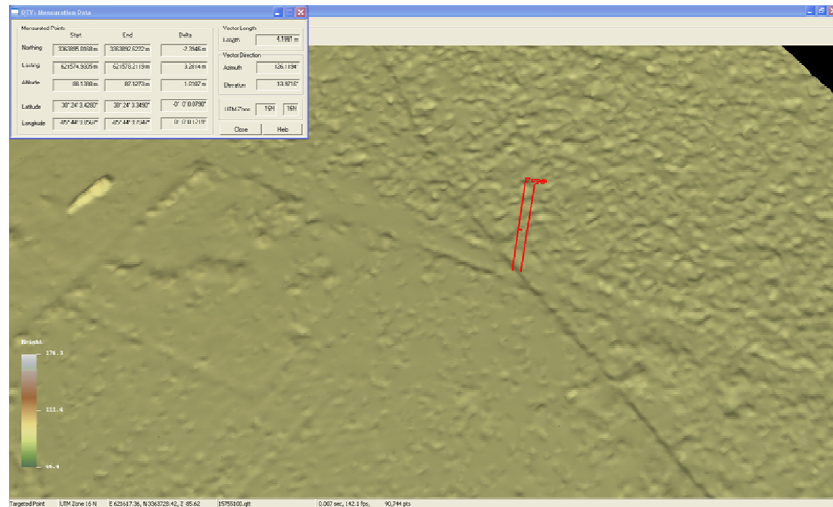
Figure 9 Tile 46068 – Flightline step

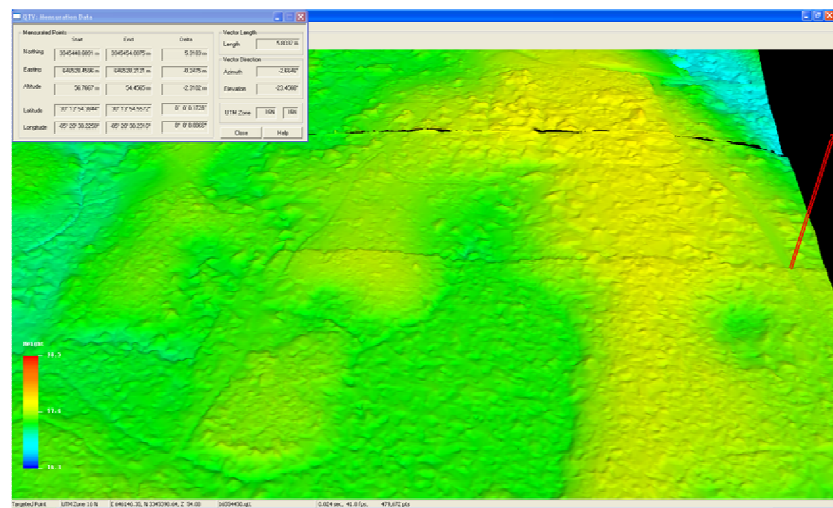
Figure 10 Tile 46069 – Flightline step

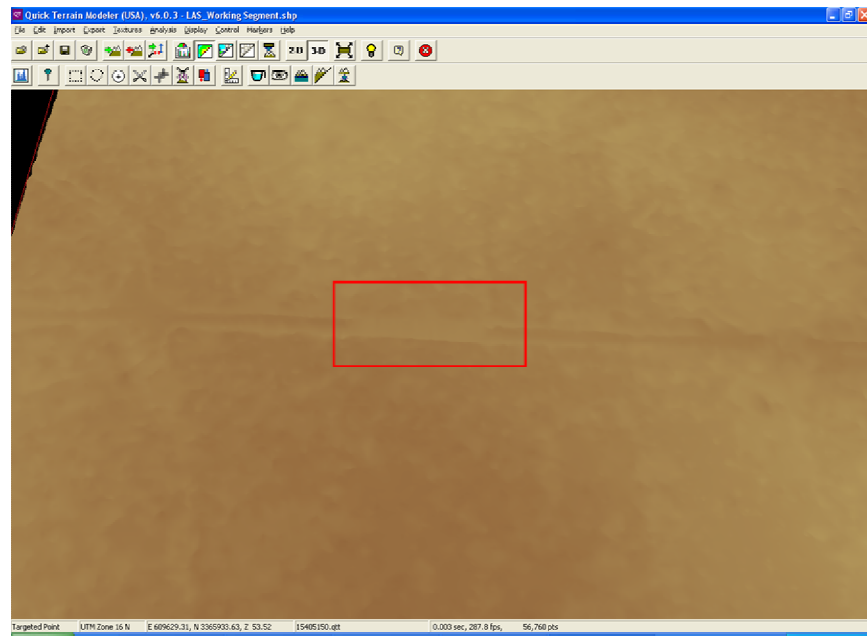
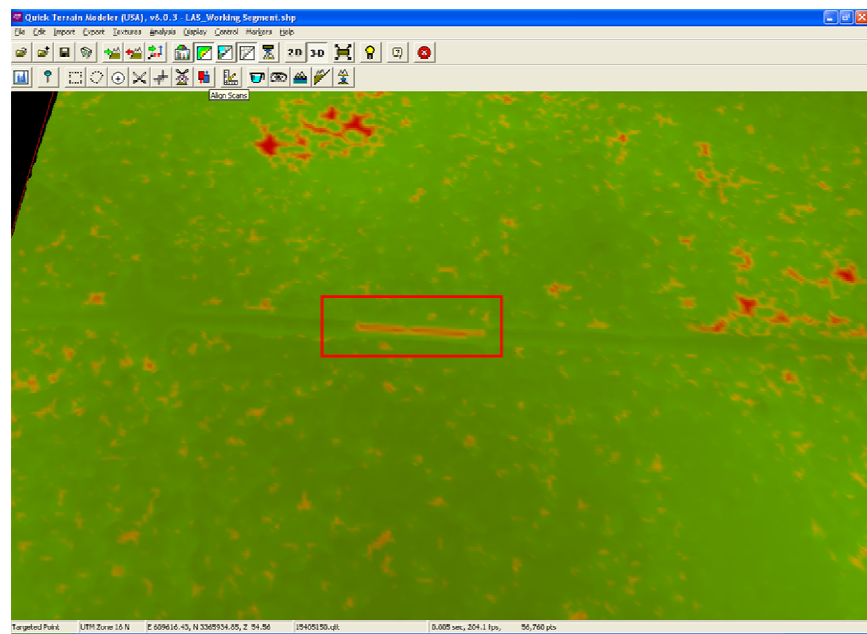
Figure 11 Tile 54152 – Lack of points on open road surface

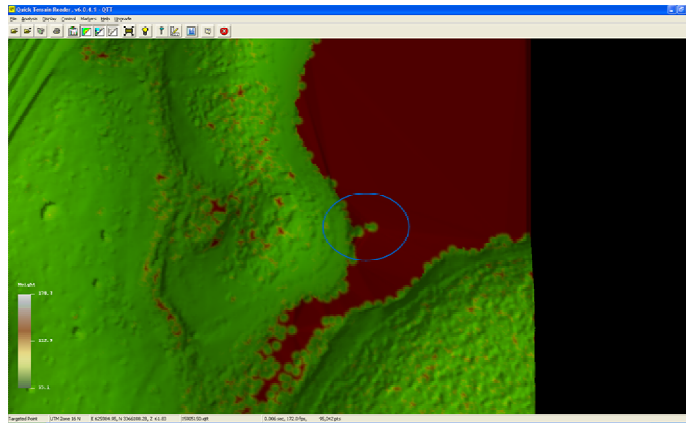
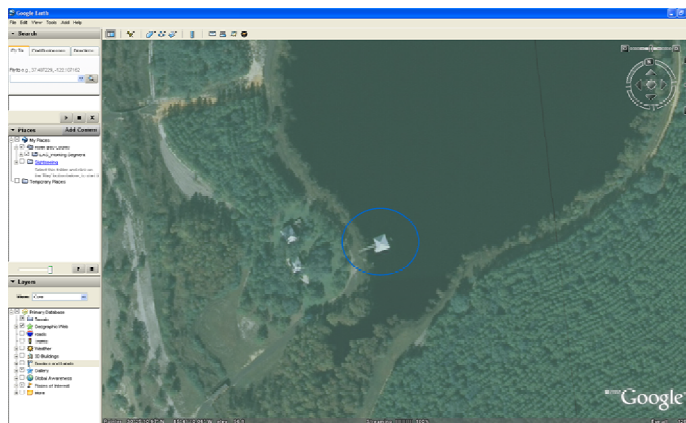
Figure 12 Tile 47655 – Docks and Piers left as ground points

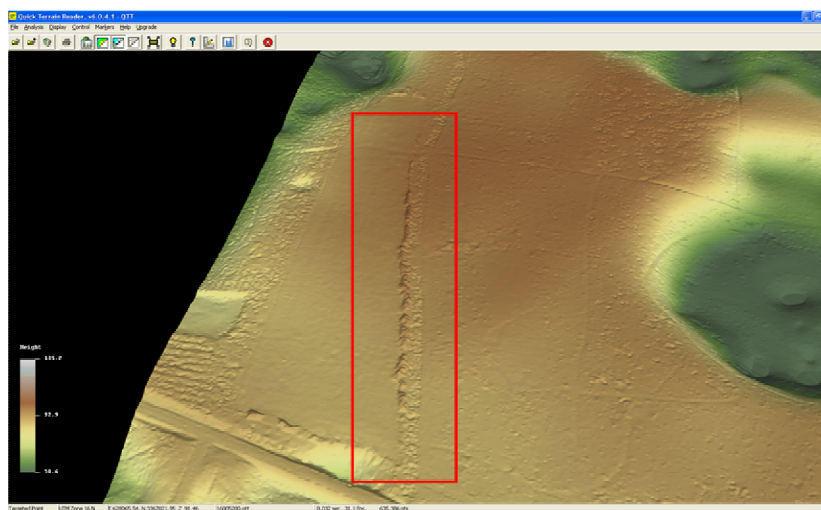
Figure 13 Tile 046604 – Irregular Terrain surrounding open field

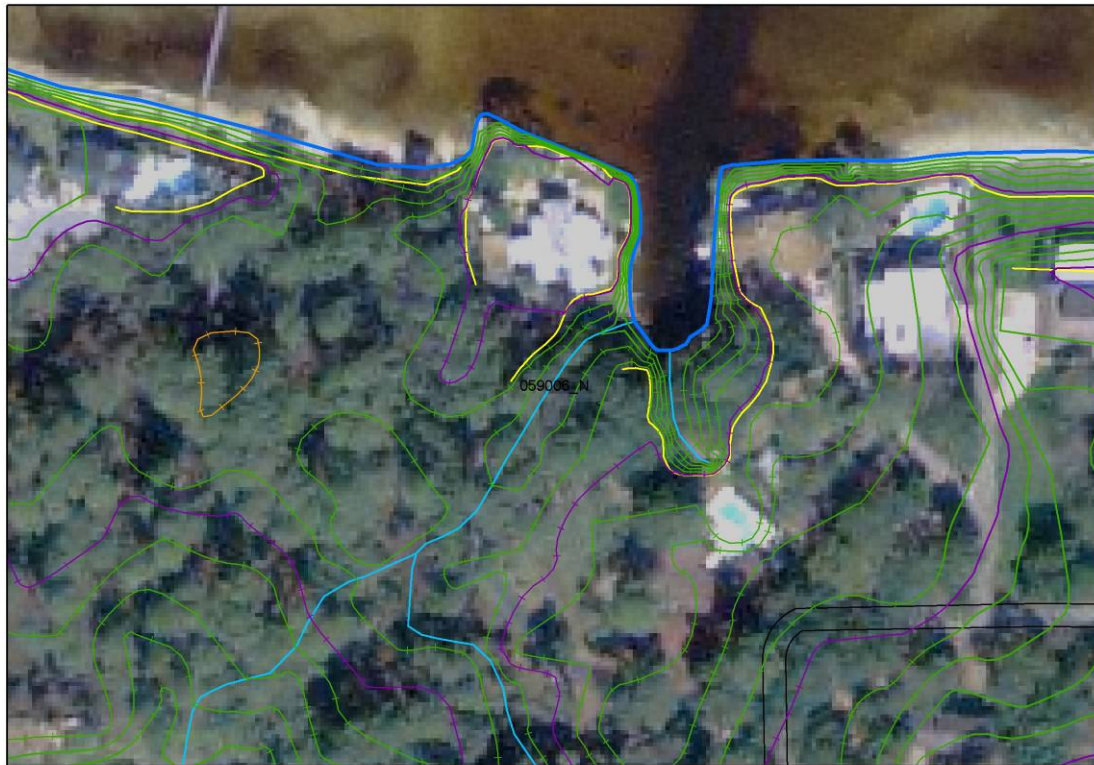
Linear hydrographic features are correctly captured as three-dimensional breaklines – single line features if the average width is 8 feet or less and dual line features if the average width is greater than 8 feet. Each vertex maintains vertical integrity. Figure 2 shows example breaklines and contours of linear hydrographic features.

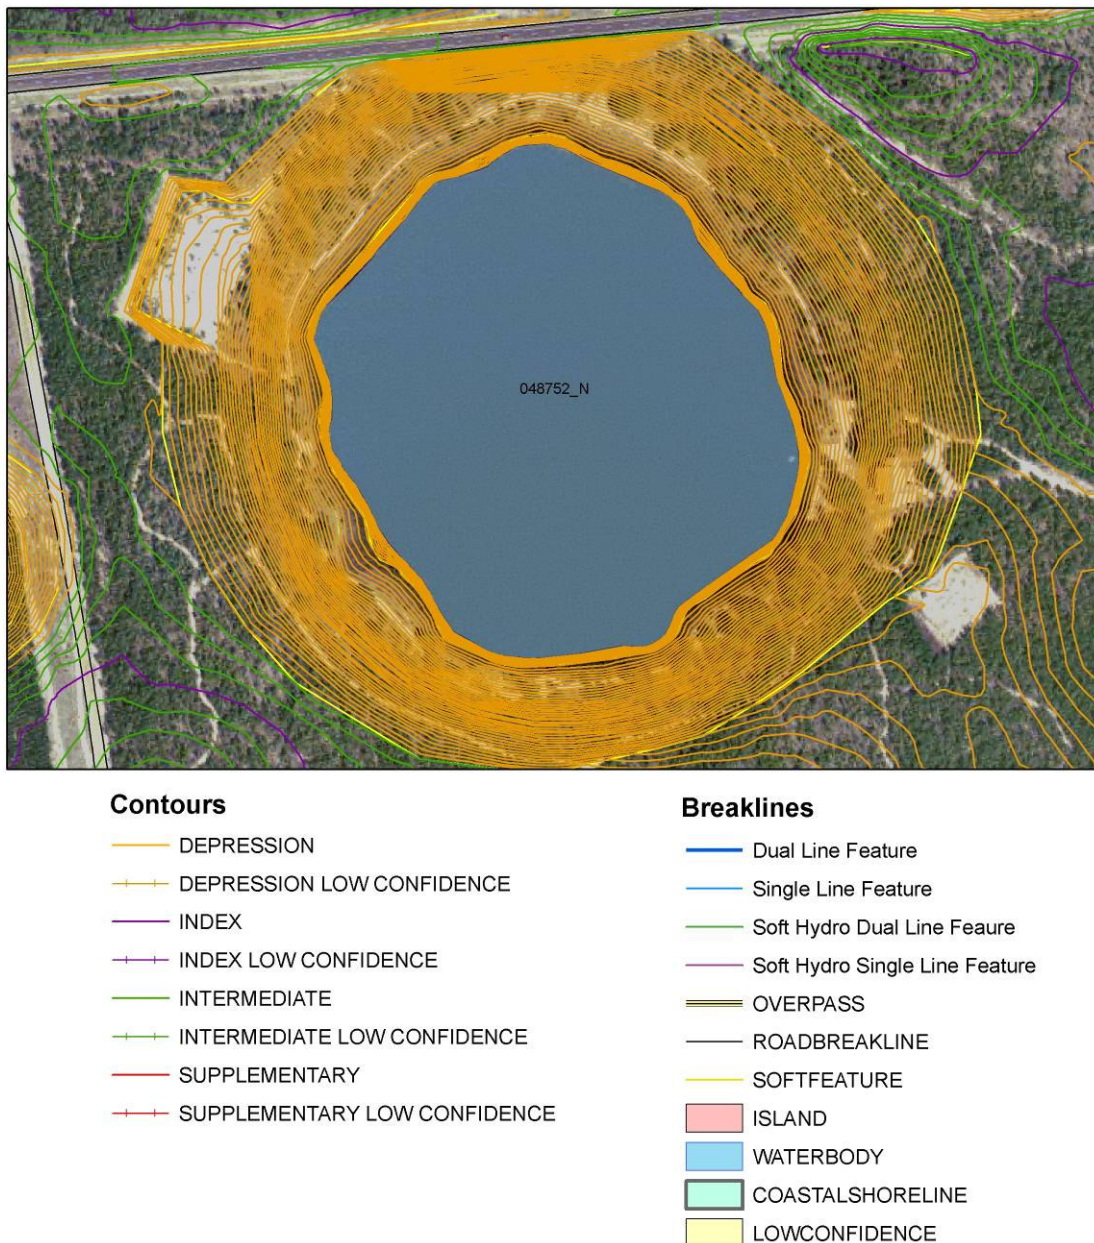
Closed water body features with an area of one-half acre or greater are correctly captured as two-dimensional closed polygons with a constant elevation that reflects the best estimate of the water elevation at the time of data capture. “Donuts” exist where there are islands within a closed water body feature. Figure 3 shows example breaklines and contours of closed water body features.

Figure 3. Example closed water body feature breaklines and contours from tile #48752

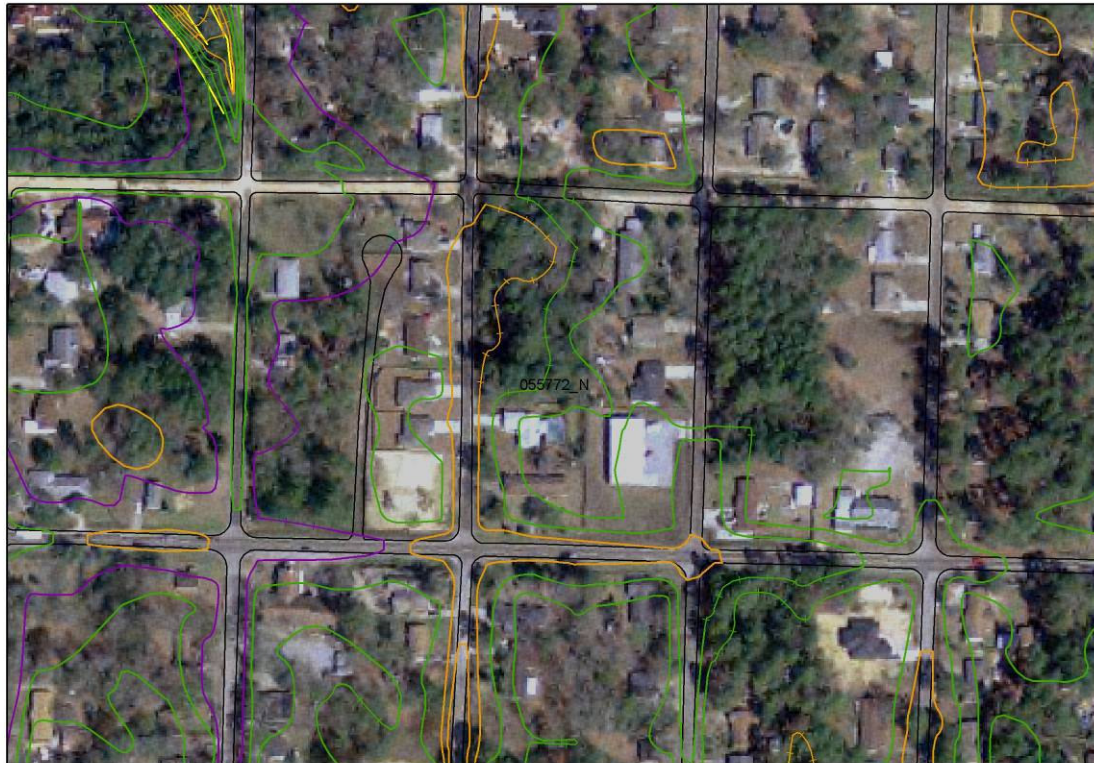
Road edge of pavement features are correctly captured as three-dimensional breaklines on both sides of paved roads. Box culverts are continued as edge of pavement unless a clear guardrail system is in place; in that case, culverts are captured as a bridge or overpass feature. Each vertex maintains vertical integrity. Figure 4 shows example breaklines and contours of road features.

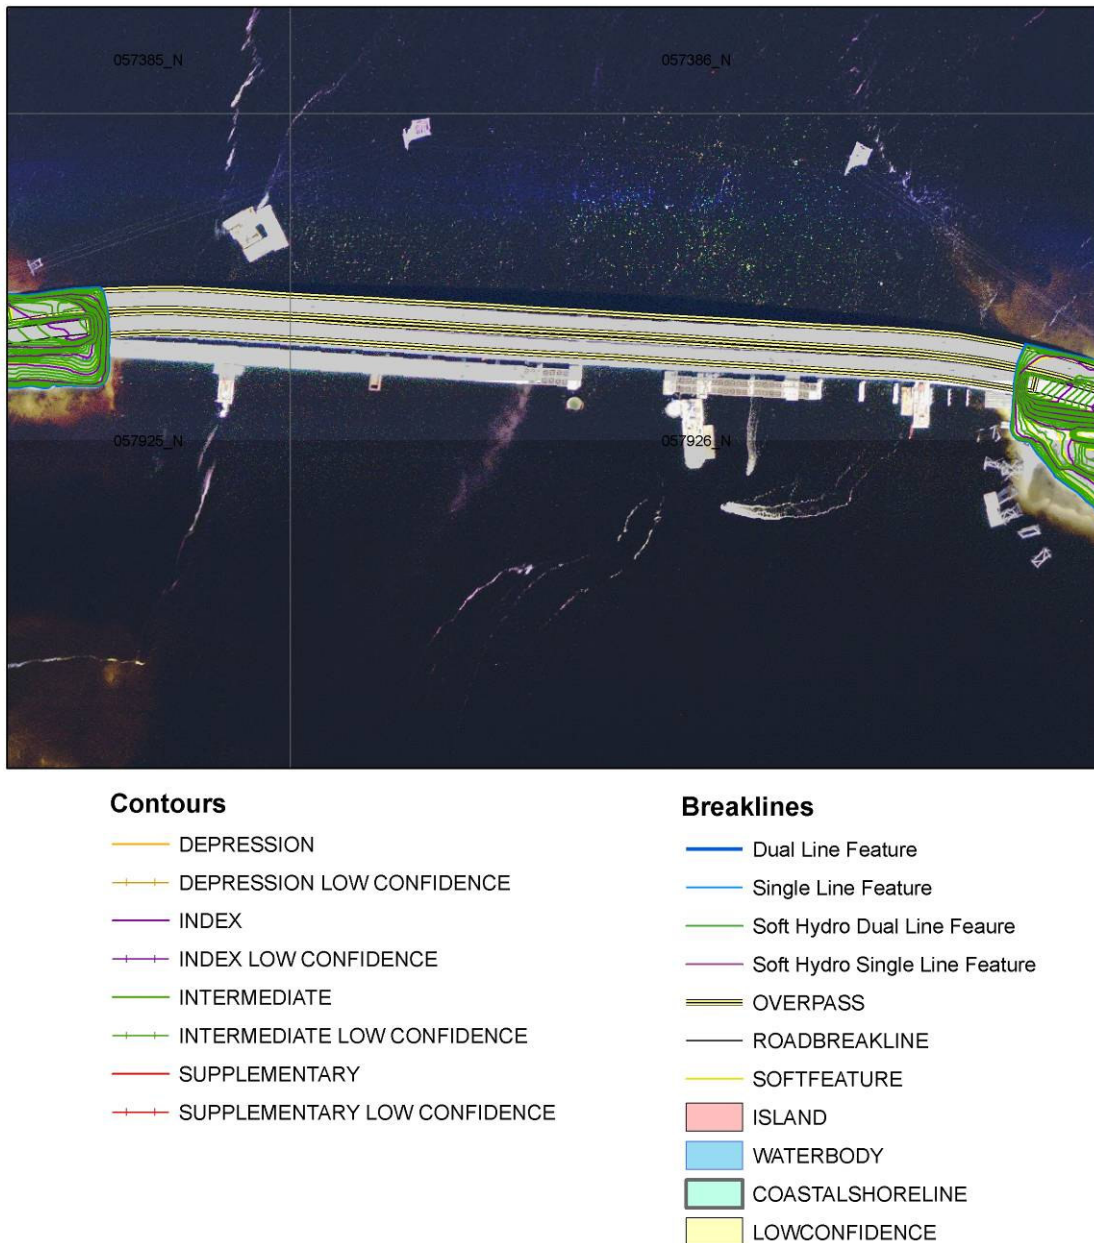
Bridges and overpasses are correctly captured as three-dimensional breaklines, capturing the edge of pavement on the bridge, rather than the elevation of guard rails or other bridge surfaces. Each vertex maintains vertical integrity. Figure 5 shows example breaklines and contours of bridge and overpass features.

Figure 5. Example bridge and overpass feature breaklines and contours from tile # 57925 & 57926

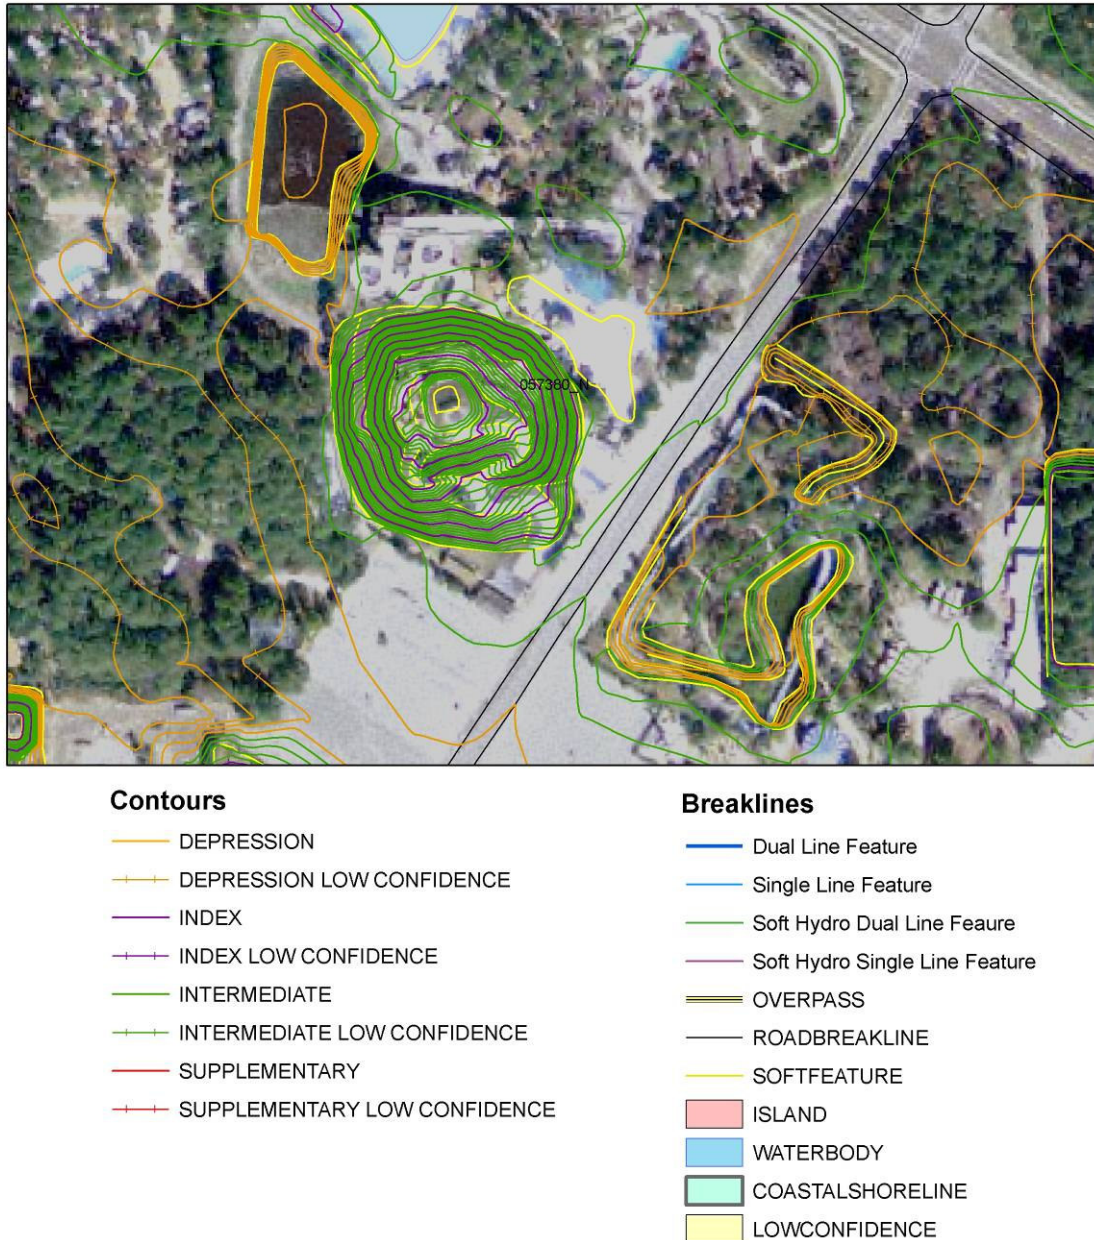
Soft features such as ridges, valleys, top of banks, etc. are correctly captured as three-dimensional breaklines so as to support better hydrological modeling of the LiDAR data and contours. Each vertex maintains vertical integrity. Figure 6 shows example breaklines and contours of soft features.

Figure 6. Example soft feature breaklines and contours from tile #57380

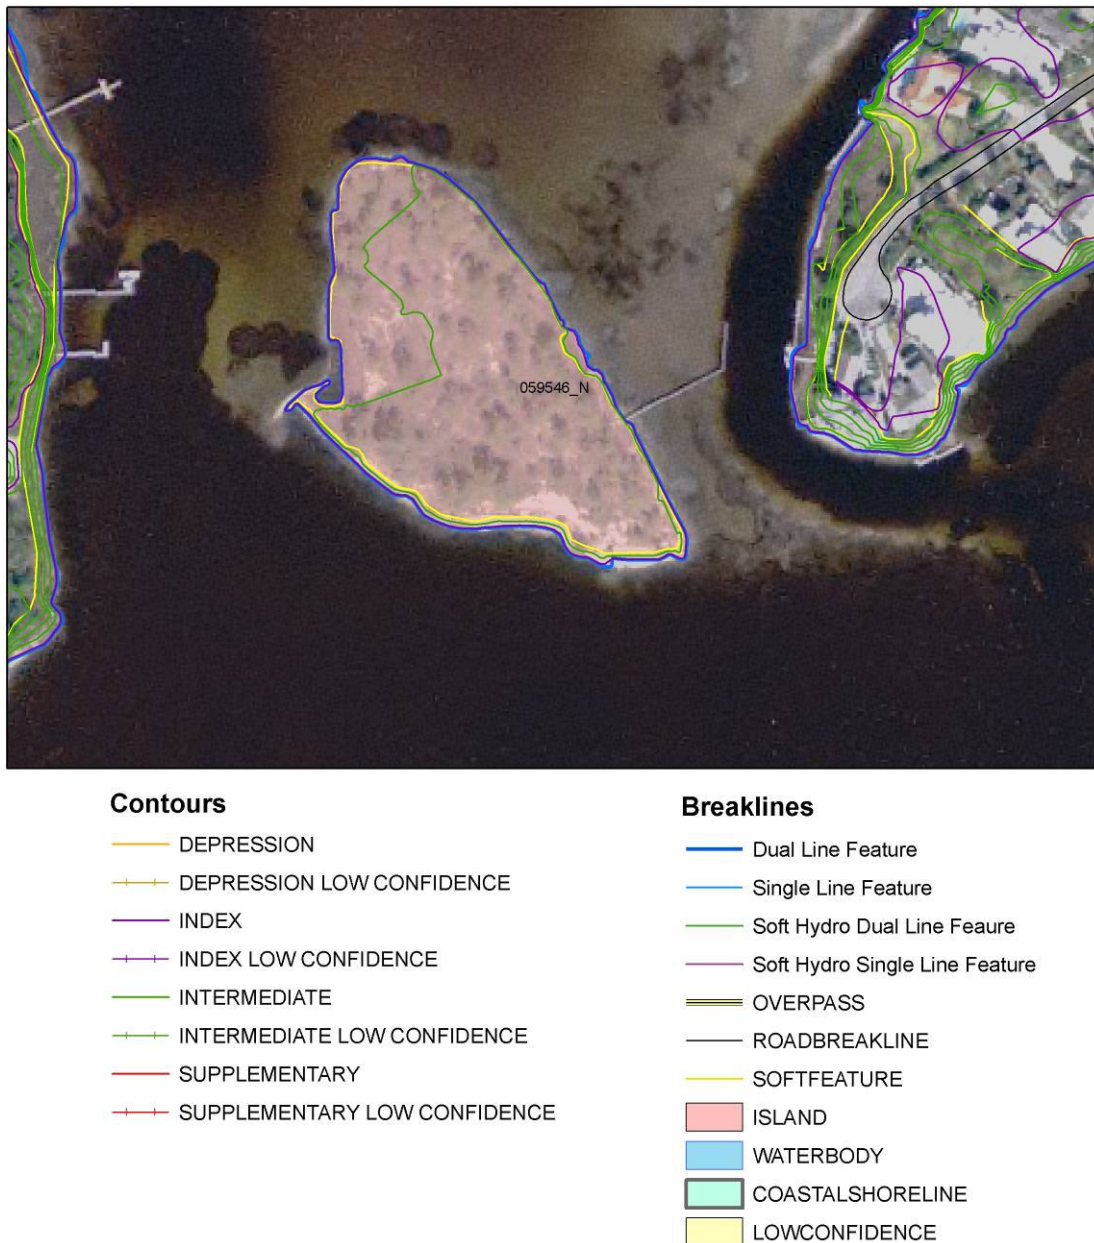
The shoreline of islands within water bodies are correctly captured as two-dimensional breaklines in coastal and/or tidally influenced areas and as three-dimensional breaklines in non-tidally influenced areas for island features one-half acre in size or greater. All natural and man-made islands are depicted as closed polygons with constant elevation. Figure 7 shows example breaklines and contours for island features.

Figure 7. Example island feature breaklines and contours from tile #59456

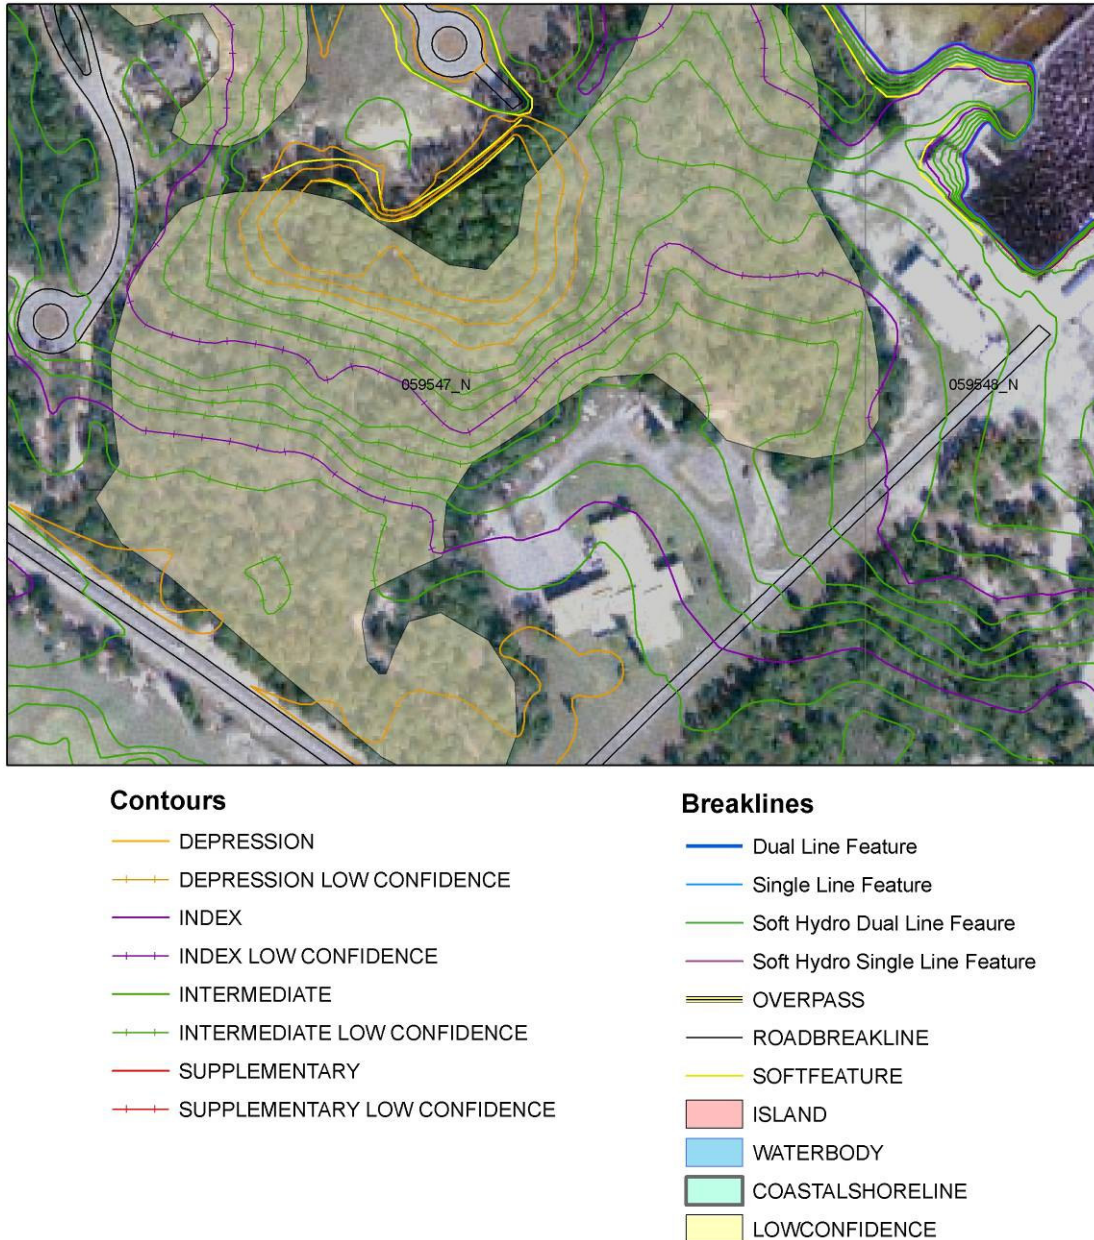
The apparent boundary of vegetated areas (1/2 acre or larger) that are considered obscured to the extent that adequate vertical data cannot be clearly determined to accurately define the DTM are correctly captured as two-dimensional features with no z-values. Figure 8 shows example breaklines and contours for low confidence areas.

Figure 8. Example low confidence area feature breaklines and contours from tile #59547
